### **IFB #2023-59 (formerly 2023-58): 1678, 1674, 1670, & 1666 DORA STREET, DOS PALOS FIRE RESTORATION & UNIT MODIFICATION**

# **ASBESTOS INSPECTION REPORT**

**BEM PROJECT NO. 23-63443**

Site  
**Residential**  
**1666 & 1674 Dora Street**  
**Dos Palos, CA 93620**

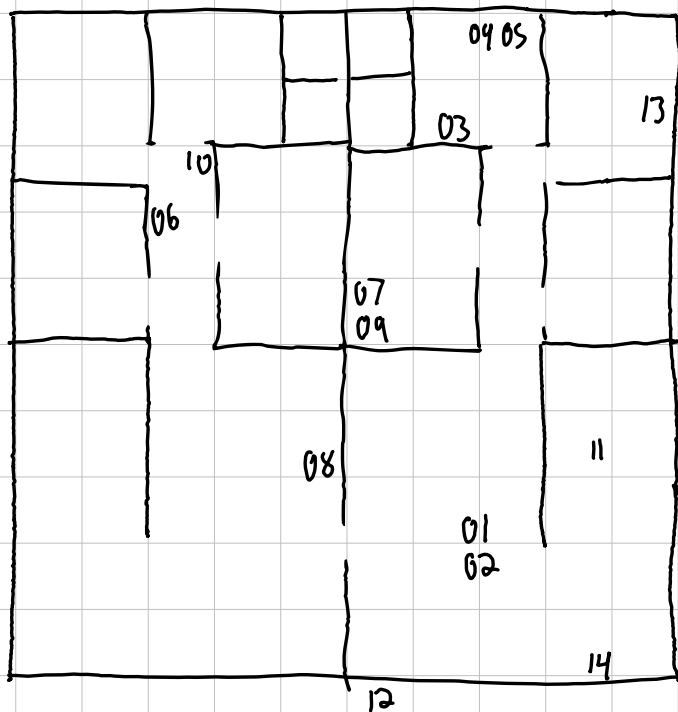
## **SITE DRAWING**

1666 Dora St. Dos Palos CA 93620
